Mair Bank Channel Edge Additional Characterisation:
Crude Freight Shipping Project,
Bream Bay, Whangarei

February 2016

For: Chancery Green on behalf of the Refining NZ

Report by: V.C. Kerr B.Sc.

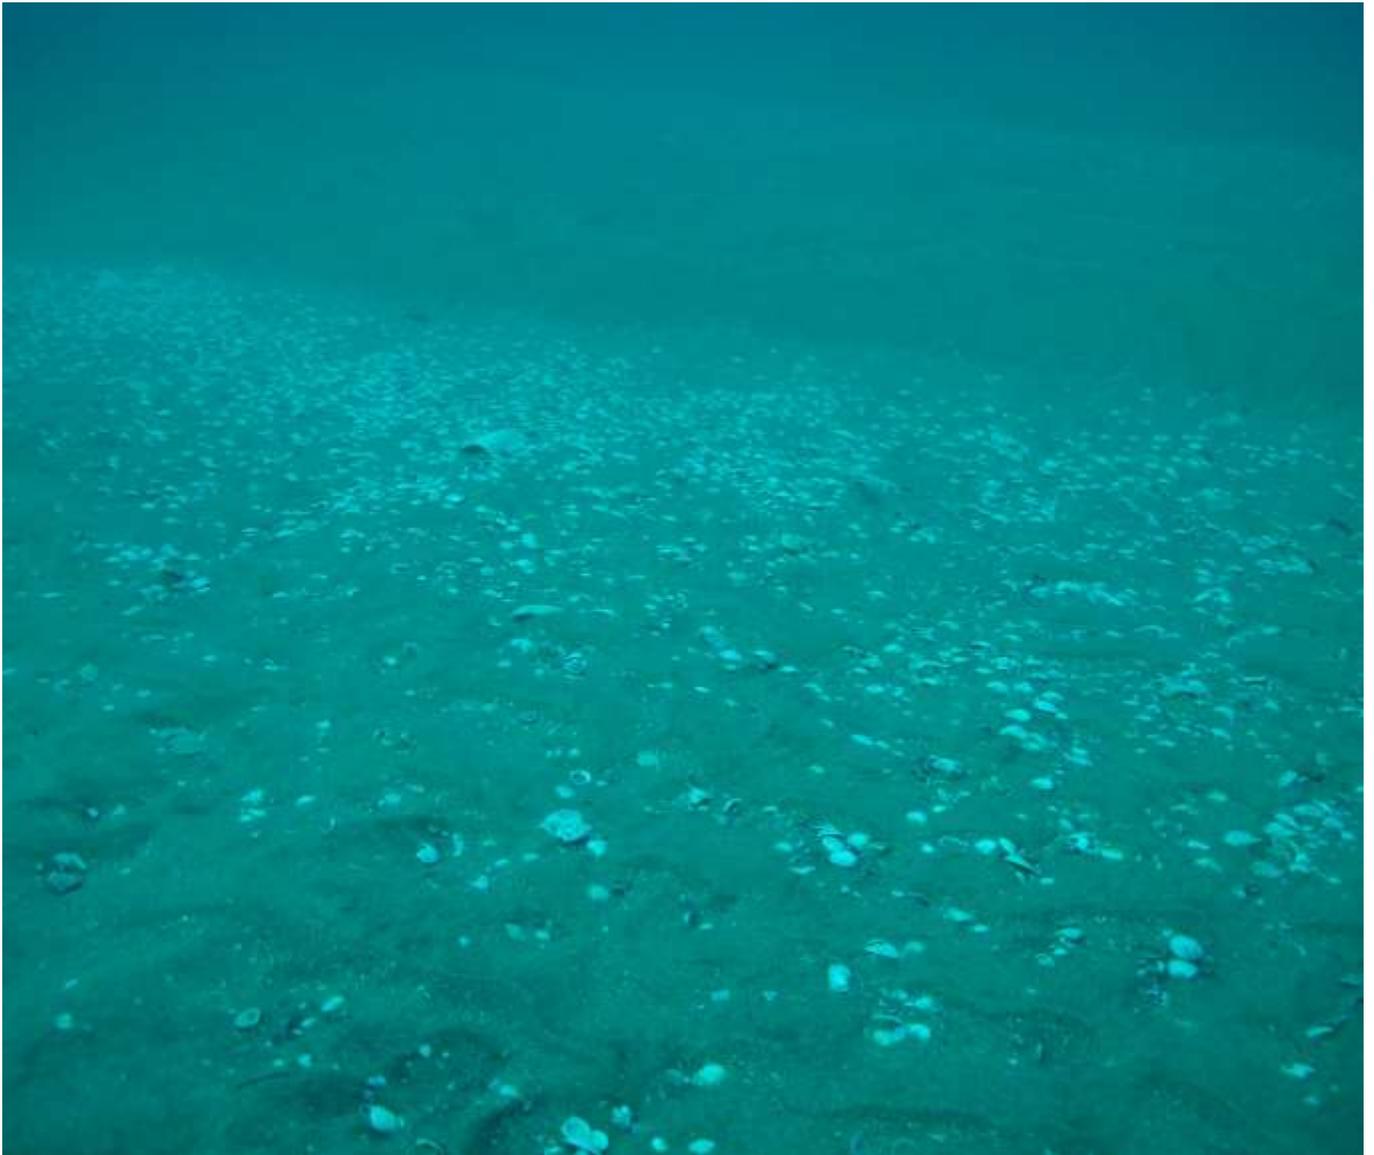
Cover Photo: Transect 3 Photo Point A showing a large sand ripple formation and fine sand with some shell and shell hash component.

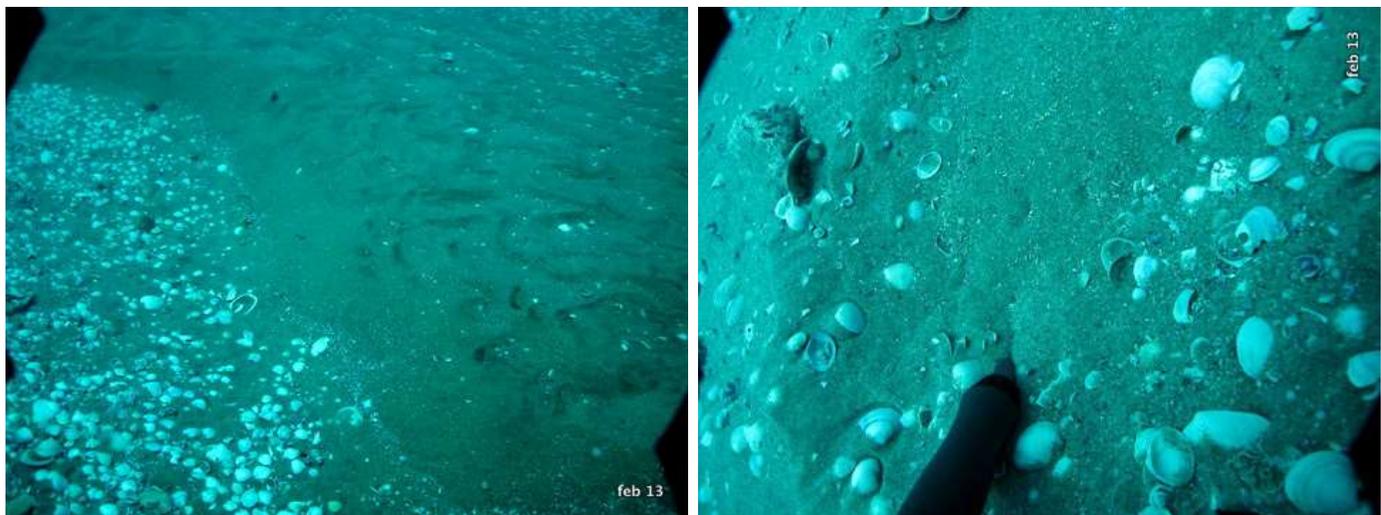
3.1.1 Photo Point A

Shell content rating = 3 (see Table 1 for description of rating)

Sediments were mainly fine sand with loose pipi, *Paphies australis* and *Tawera speciosa* shell. There were only very small quantities of silt and shell hash. Coarse sand and gravels were not observed in any significant quantity. Sand ripples are prominent and covered the entire area. The sand ripple wave period was approx. 2-3m and wave height approx. 200-300mm. Substrate did not appear to be consolidated to a great extent. . When digging, the trowel went in smoothly to full depth with little effort. The hole quickly filled in from the sides when dug. There was no change in substrate at 200-300mm depth. No live shellfish were seen.

Figure 4 Photo point A: (left) showing sand wave ridge, (right) showing excavation hole filling in with loose sand as trowel is thrust in full length. Depth -14.1m.

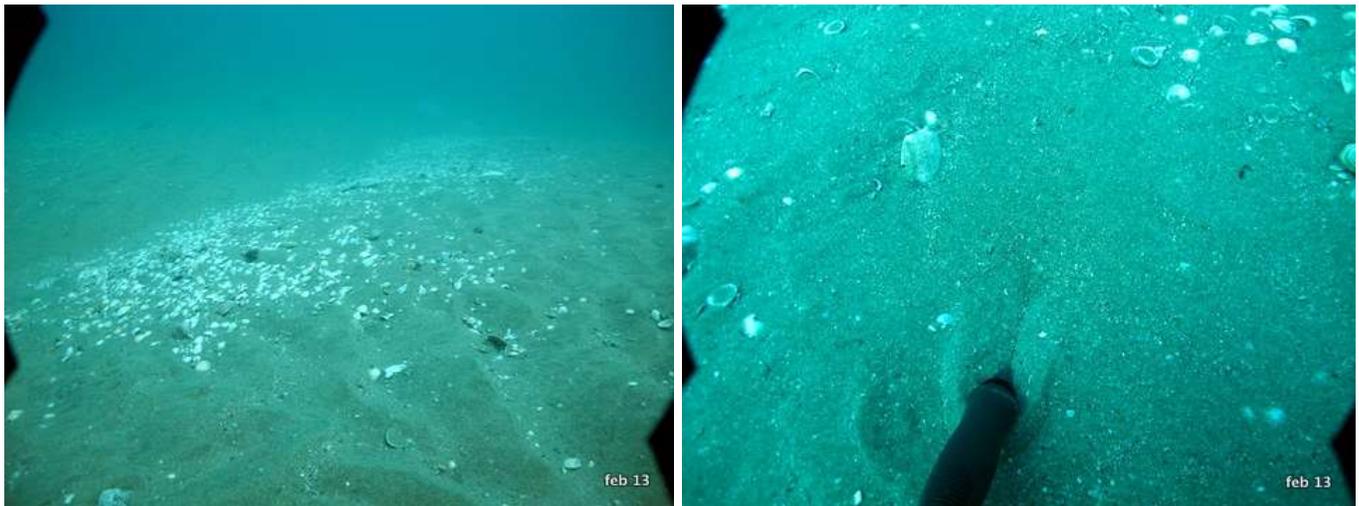
3.1.2 Photo Point B

Shell content rating = 3 (see Table 1 for description of rating)

There was essentially no change from Photo point A, sediments were mainly fine sand with loose pipi, *Paphies australis* and *Tawera speciosa* shell, with only very small quantities of silt and shell hash. Coarse sand and gravels were not observed in any significant quantity. Sand ripples are prominent and covered the entire area. The sand ripple wave period was approx., 2-3m and height approx. 200-300mm. Substrate did not appear to be consolidated to a great extent. When digging the trowel went in smoothly to full depth with little effort. The hole quickly filled in from the sides when dug. There was no change in substrate at 200-300mm depth. No live shellfish were seen. One small green algae was seen, *Codium sp.*

Figure 5 Photo point B: (left) showing sand wave ridge, (right) showing excavation hole filling in with loose sand as trowel is thrust in full length. Depth -11.9m.

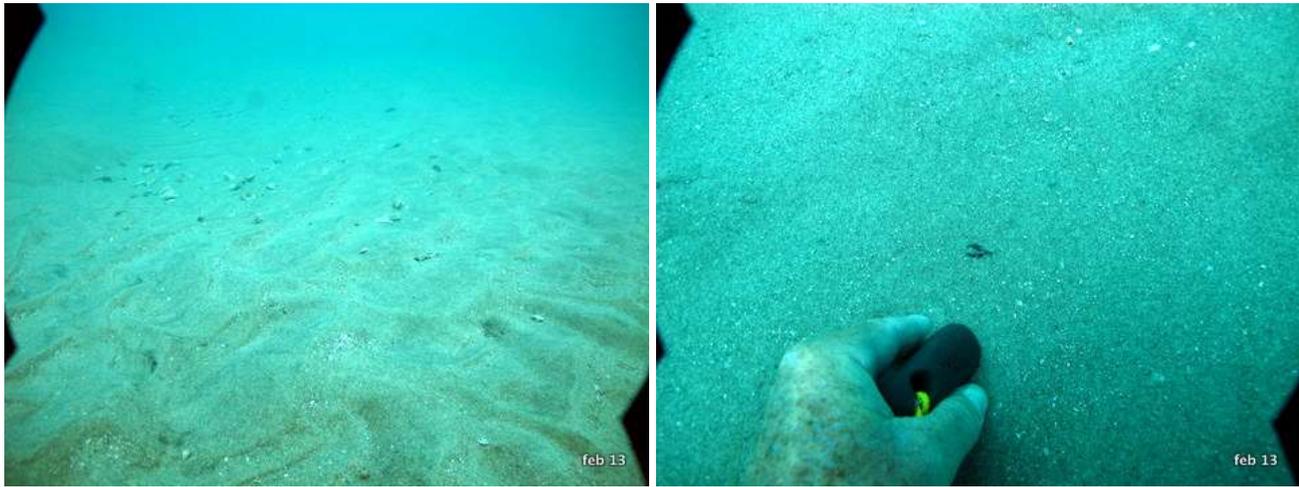
3.1.3 Photo Point C

Shell content rating = 1 (see Table 1 for description of rating)

Substrate is predominantly fine sand with very little silt or gravel content. There is a small proportion of shell hash. Larger shells are present mixed through the substrate but are a relatively minor component. There is a dual pattern of wave ripples present with a large wave with approx. 2m period and small wave ripple with approx. 300mm period. The excavation hole filled constantly while digging indicating that the substrate is unconsolidated. There was no change in the substrate composition at 200mm depth. No live shellfish were seen.

Figure 6 Photo point C: (left) showing large and small wave ridges, (right) showing excavation hole filling in completely with loose sand as trowel is thrust in full length. Depth -10.1m

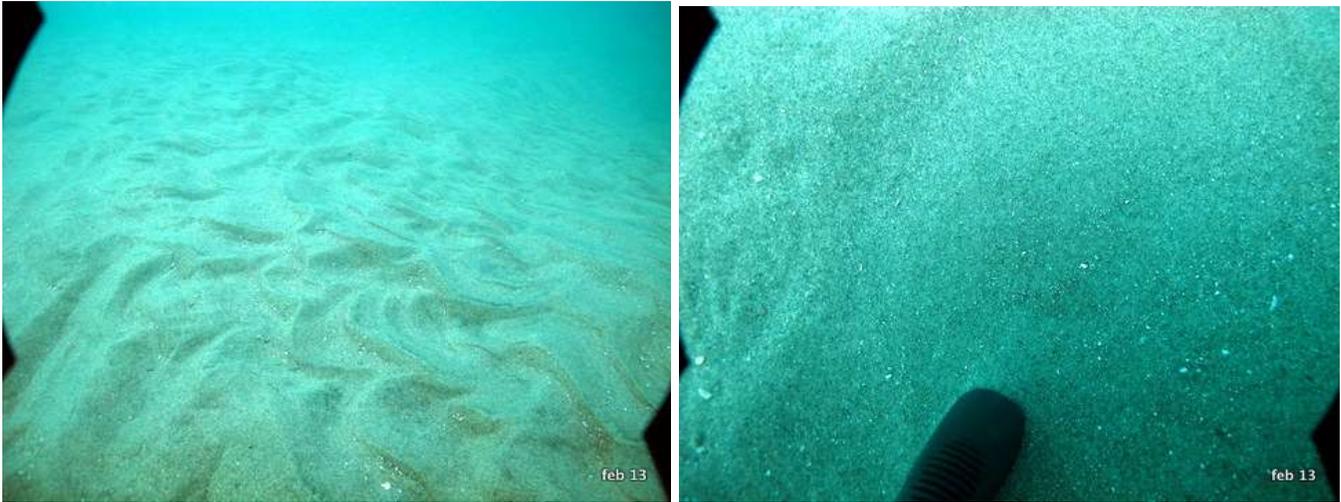
3.1.4 Photo Point D

Shell content rating = 1 (see Table 1 for description of rating)

Substrate is predominantly fine sand with very little silt or gravel content. There is a very small proportion of shell hash. Larger shells are nearly absent. There is a dual pattern of wave ripples present with a large wave with approx. 2m period and small wave ripple with approx. 300mm period. The excavation hole filled constantly while digging indicating that the substrate is unconsolidated. There was no change in the substrate composition at 200mm depth. No live shellfish were seen.

Figure 7 Photo point D: (left) showing sand wave ridges, (right) showing excavation hole filling in with loose sand as trowel is thrust in full length. Depth -8.1m.

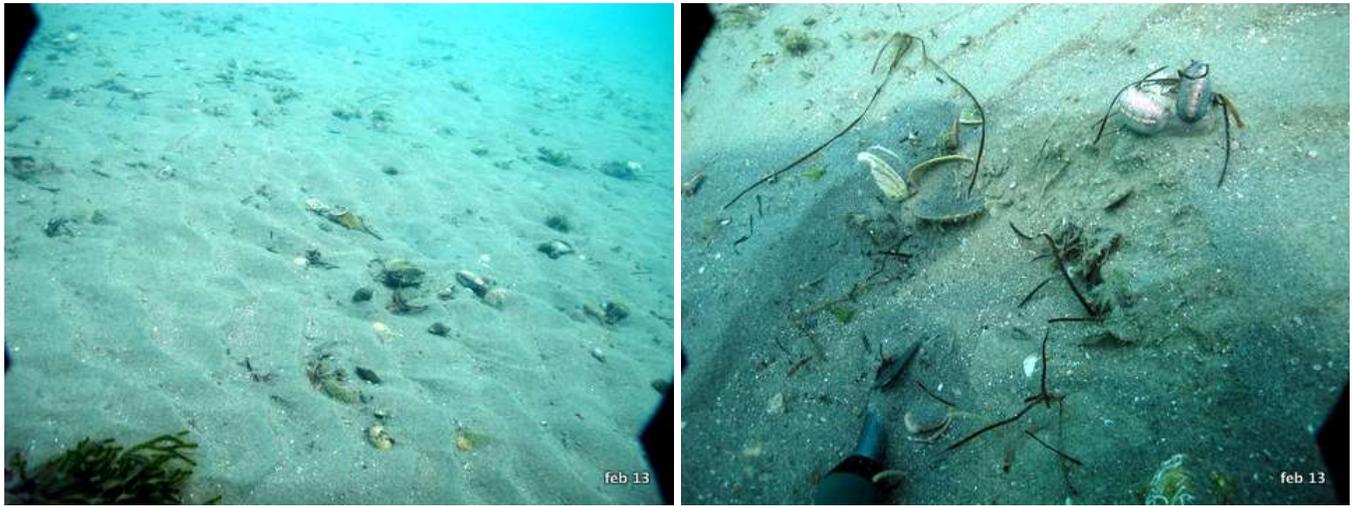
3.1.5 Photo Point E

Shell content rating = 3 (see Table 1 for description of rating)

Substrate is predominantly fine sand with very little silt or gravel content. There is a very small proportion of shell hash. Larger shells are present. There is a small pattern of wave ripples with an approx. 300mm period. While digging shells were encountered but it was easy to thrust the trowel into the substrate to its full length. The hole mostly filled back in while digging indicating that the substrate is largely unconsolidated. There was no change in the substrate composition at 200mm depth. One live pipi was seen while digging. Judging from the relatively fresh (non-living) shell present there could be a low density of pipi living here.

Figure 8 Photo point E: (left) showing small sand wave ridge, (right) showing excavation hole filling in with loose sand as trowel is thrust in full length, two limpets seen at top right of hole. Depth -6m.

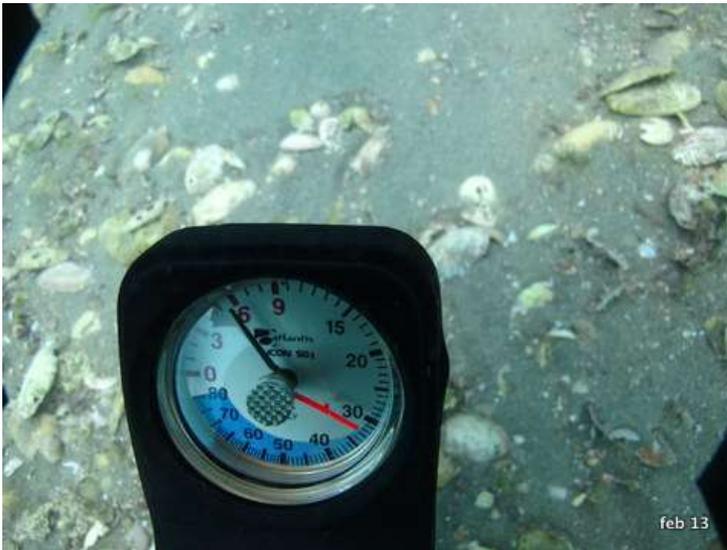
3.1.6 Photo Point F

Shell content rating = 6 (see Table 1 for description of rating)

Substrate was fine sand with a component of shell hash. Large dead shells were a significant component. There were no sand ripples present. The substrate was fairly hard to dig due to the amount of large shell evenly mixed through the substrate to 200mm depth. The shell and substrate composition was uniform down to 200mm depth. There were no live shellfish seen.

Figure 9 Photo point F: showing high shell content and armouring of seabed. Depth = -2.8m. Note depth gauge is an uncorrected high tide reading.

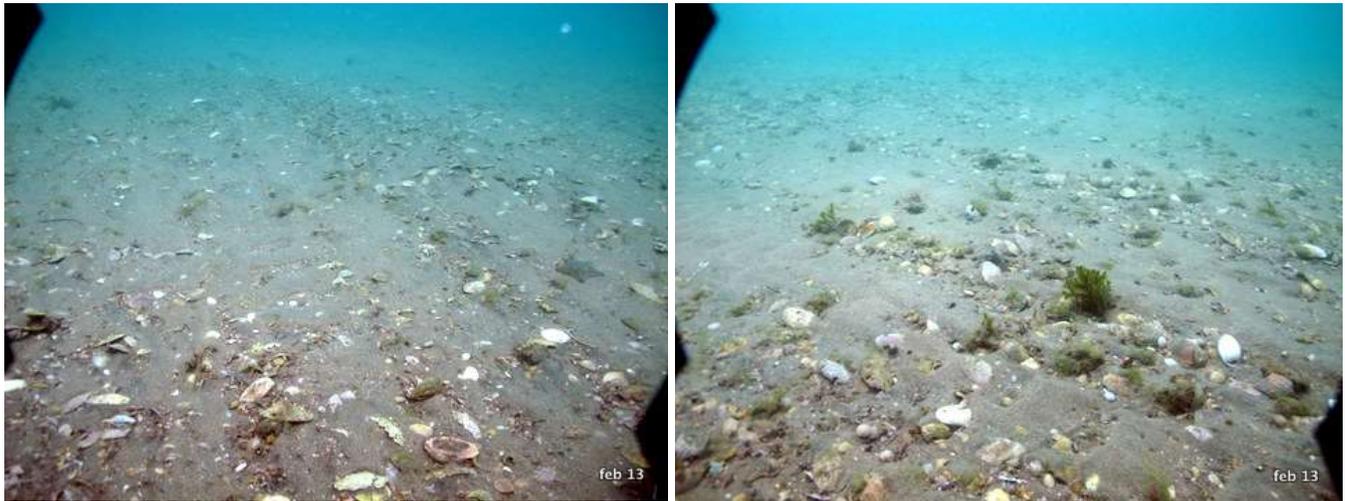
3.1.7 Photo Point G

Shell content rating = 7 (see Table 1 for description of rating)

Substrate was fine sand with a component of shell hash. Large dead shells were a significant component. The surface was somewhat undulating but not in a formal wave pattern. Some small irregular sand ripples were present. The substrate was fairly hard to dig due to the amount of large shell evenly mixed through the substrate to 200mm depth. The shell and substrate composition was uniform down to 200mm depth. There were no live shellfish seen. The small green algae *Codium sp.* were present in low density.

Figure 10 Photo point G: showing fine sand, high shell content and presence of green algae *Codium sp.* Depth -2.8m.

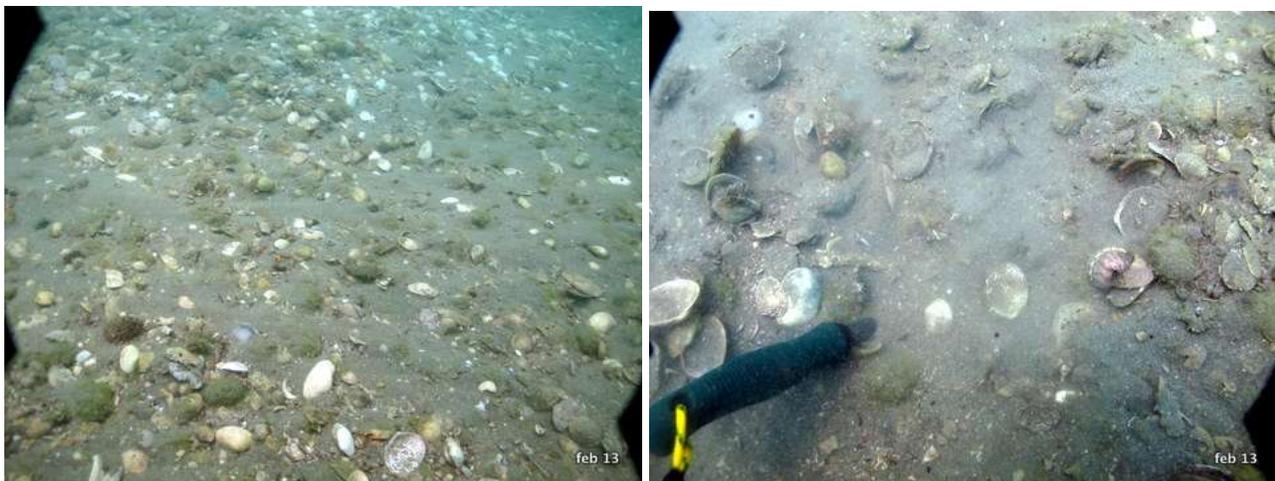
3.1.8 Photo Point H

Shell content rating = 8 (see Table 1 for description of rating)

Substrate was fine sand with a component of shell hash. Large dead shells were a significant component. The surface was somewhat undulating but not in a formal wave pattern. Some small irregular sand ripples were present. The substrate was fairly hard to dig due to the amount of large shell evenly mixed through the substrate to 200mm depth. The shell and substrate composition was uniform down to 200mm depth. There were no live shellfish seen. The small green algae *Codium sp.* were present in low density.

Figure 11 Photo point H: (left) showing flat armoured surface with high shell content, (right) showing excavation hole partially filling in with loose sand as trowel is thrust in full length. Depth -2.3m.

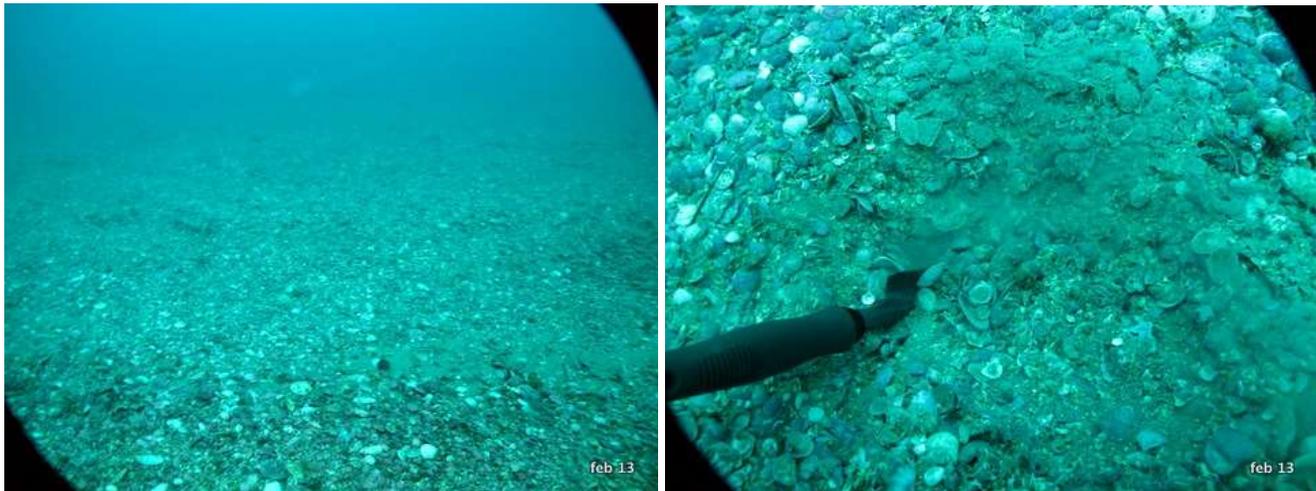
3.2.1 Photo Point I

Shell content rating = 10 (see Table 1 for description of rating)

Substrate was a mix of shell hash loose shell and fine sand. There was a small amount of silt present. The shell hash and loose shell makes up a large proportion of the substrate and was evenly mixed down to 200mm. The substrate appeared to be quite consolidated and relatively stable. The excavation hole took some effort to dig due to the large shell content and filled in only slightly when digging. There was a fairly flat wave ridge pattern with an approx. 2m period. There were no live shellfish seen.

Figure 12 Photo point I: (left) showing wave pattern with ridges running left to right, (right) showing excavation hole. Depth -16.8m.

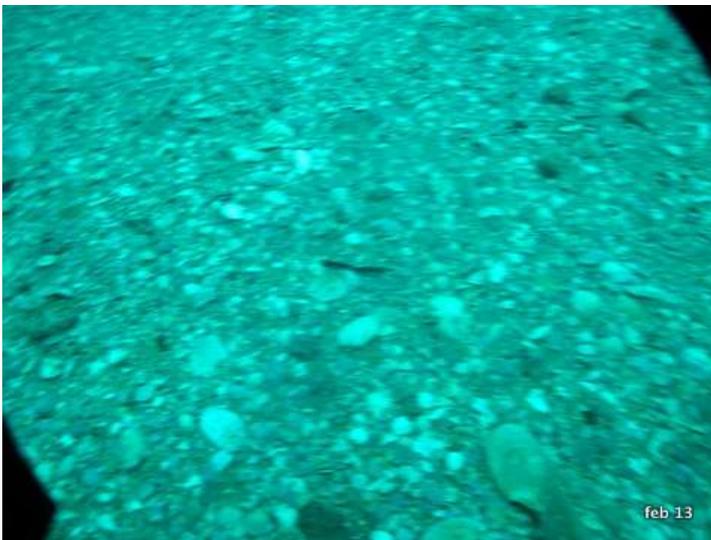
3.2.2 Photo Point J

Shell content rating = 10 (see Table 1 for description of rating)

Substrate was a mix of shell hash, loose shell and fine sand. There was a small amount of silt present. The shell hash and loose shell made up a large proportion of the substrate and was evenly mixed down to 200mm. The substrate appeared to be quite consolidated and relatively stable. The excavation hole took some effort to dig due to the large shell content and filled in only slightly when digging. The surface was fairly flat with no real wave pattern present. There were no live shellfish seen.

Figure 13 Photo point J: showing high shell content. Depth -14.2m.

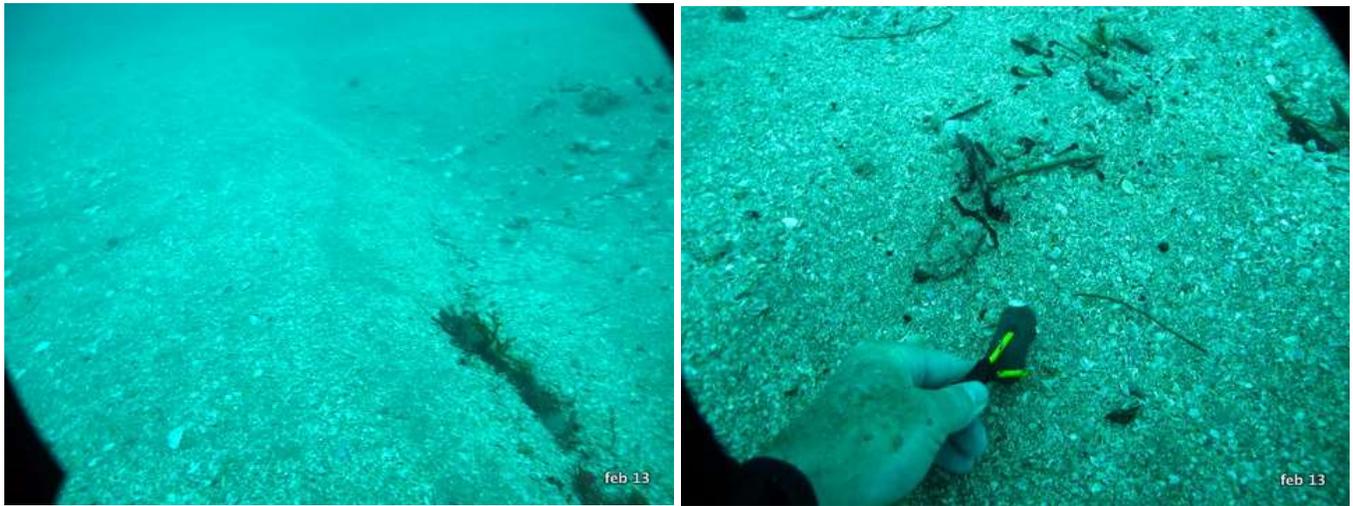
3.2.3 Photo Point K

Shell content rating = 3 (see Table 1 for description of rating)

Substrate is predominantly fine sand with a significant component of shell hash but very little silt or gravel content. Larger shells are present mixed through the substrate but are a relatively minor component. There is a steep pattern of wave ripples present with a wave period of approx. 1m. The excavation hole filled constantly while digging indicating that the substrate is unconsolidated. There was no change in the substrate composition at 200mm depth. No live shellfish were seen.

Figure 14 Photo point K: (left) showing sand wave ridge, (right) showing excavation hole filling in with loose sand as trowel is thrust in full length. Depth -13.2m.

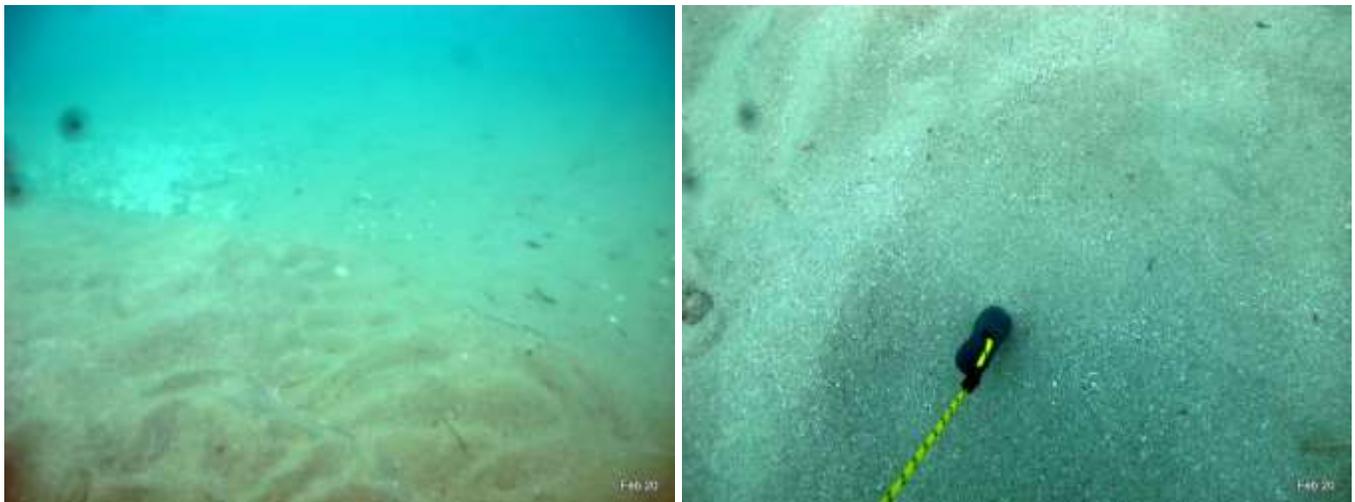
3.2.4 Photo Point T

Shell content rating = 1 (see Table 1 for description of rating)

Substrate is predominantly fine sand with a component of fine shell hash but very little silt or gravel content. Larger shells are present mixed through the substrate but are a relatively minor component There is a dual pattern of wave ripples present with a large wave period of approx. 2m and a small wave ripple with a period of approx.200mm. The excavation hole filled constantly while digging indicating that the substrate is unconsolidated. There was no change in the substrate composition at 200mm depth. No live shellfish were seen.

Figure 15 Photo point T: (left) showing sand wave ridges, (right) showing excavation hole filling in with loose sand as trowel is thrust in full length. Depth -9.6m.

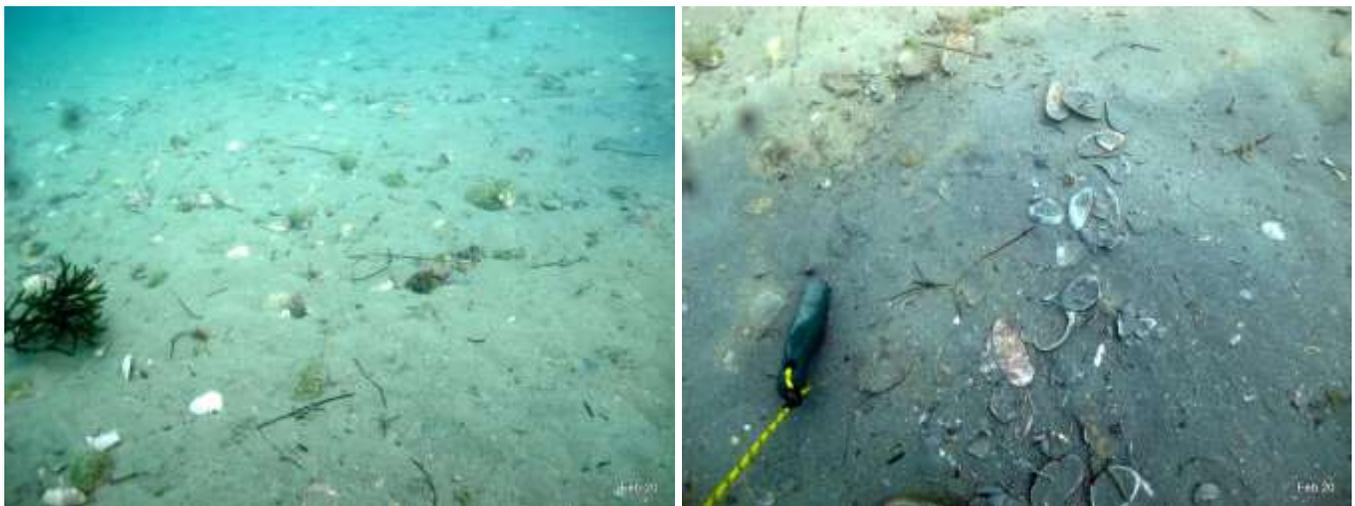
3.2.5 Photo Point U

Shell content rating = 5 (see Table 1 for description of rating)

Substrate was fine sand with a small component of shell hash. Large dead shells were a significant component. There were no sand ripples present. The substrate was fairly hard to dig due to the amount of large shell evenly mixed through the substrate to 200mm depth. The substrate was uniform in composition through the 200mm profile. There were no live shellfish seen.

Figure 16 Photo point U: (left) showing flat surface and presence of large shells, (right) showing excavation hole filling in with loose sand as trowel is thrust in full length and large shells and shell hash to left excavated from the hole. Depth -7.4m

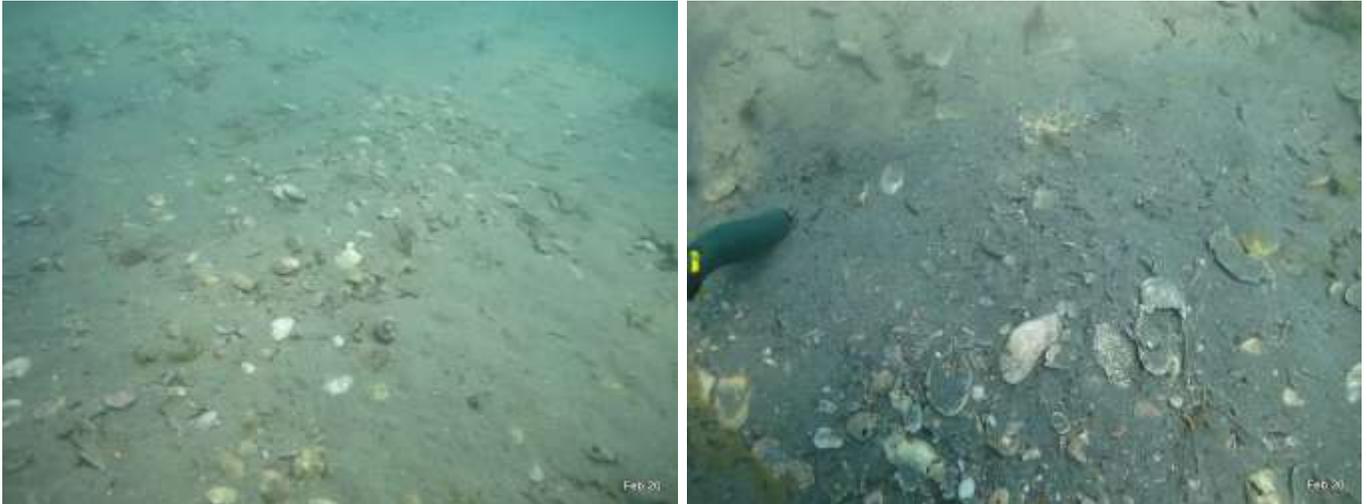
3.2.6 Photo Point V

Shell content rating = 6 (see Table 1 for description of rating)

Substrate was fine sand with a significant component of shell hash. Large dead shells were also a significant component. There were no sand ripples present. The substrate was fairly hard to dig due to the amount of large shell evenly mixed through the substrate to 200mm depth. The substrate was uniform in composition through the 200mm profile. There were no live shellfish seen.

Figure 17 Photo point V: (left) showing significant shell content, (right) showing excavation hole filling in with loose sand as trowel is thrust in full length and shell fragments to the left excavated from the whole. Depth -4.9m.

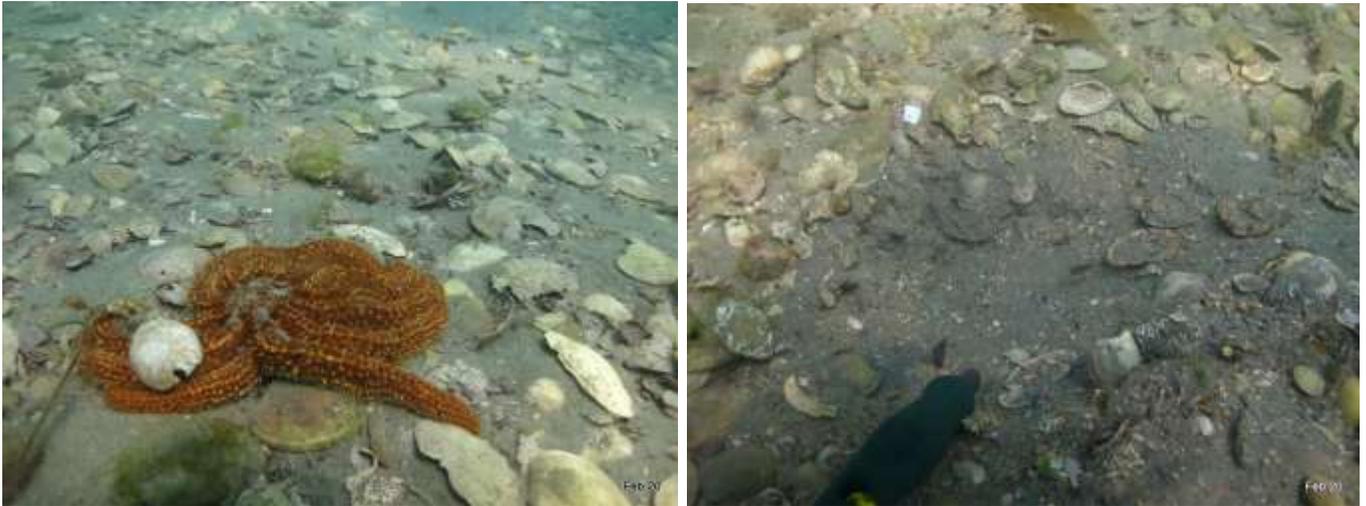
3.2.7 Photo Point W

Shell content rating = 7 (see Table 1 for description of rating)

Substrate was fine sand with a significant component of shell hash and large dead shell. Large dead shells cover most of the surface. There were no sand ripples present. The substrate was fairly hard to dig due to the amount of large shell evenly mixed through the substrate to 200mm depth. The substrate was uniform in composition through the 200mm profile. There were no live shellfish seen.

Figure 18 Photo point W: (left) showing high shell content and eleven armed starfish *Coscinasterias calamaria*, (right) showing excavation hole filling in with loose sand as trowel is thrust in full length and shell content to left excavated from the hole.. Depth -3.6m.

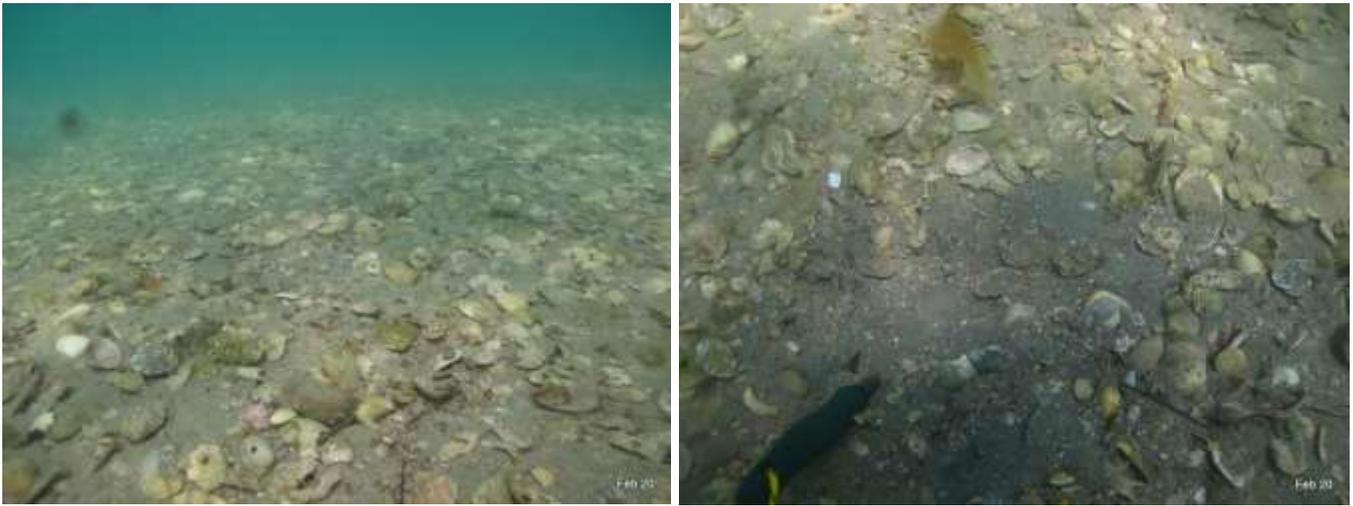
3.2.8 Photo Point X

Shell content rating = 9 (see Table 1 for description of rating)

Substrate was fine sand with a significant component of shell hash and large dead shell. Large dead shells cover most of the surface. There were no sand ripples present. The substrate was fairly hard to dig due to the amount of large shell evenly mixed through the substrate to 200mm depth. The substrate was uniform in composition through the 200mm profile. There were no live shellfish seen.

Figure 19 Photo point X: (left) showing high shell content, (right) showing excavation hole filling in with loose sand as trowel is thrust in full length and high shell content. Depth -2.9m

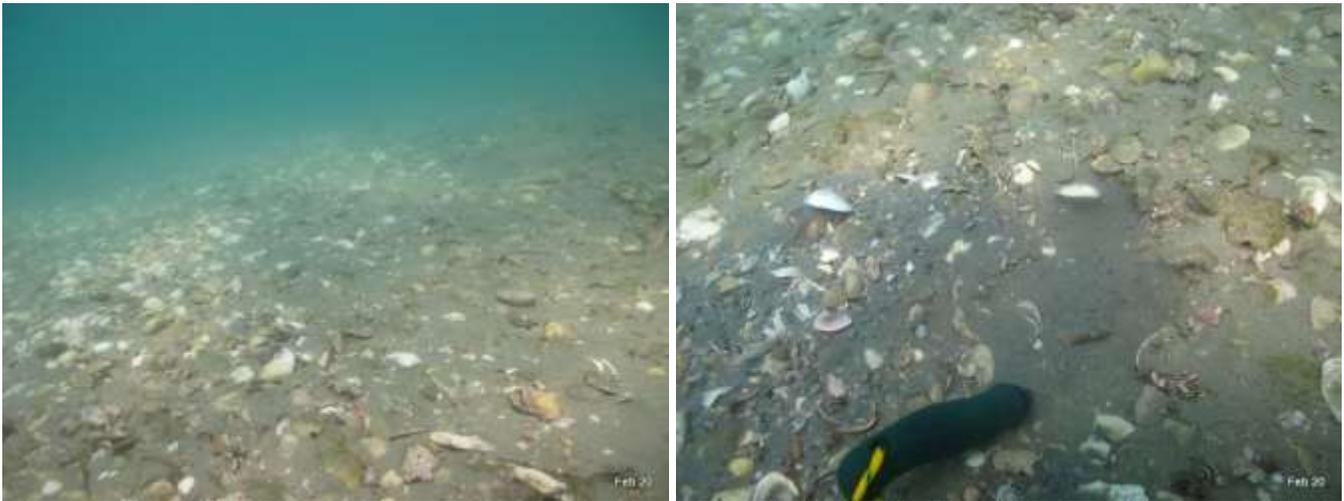
3.2.9 Photo Point Y

Shell content rating = 8 (see Table 1 for description of rating)

Substrate was fine sand with a significant component of shell hash and large dead shell. Large dead shells cover most of the surface although there were some signs of some sand moving. There were no sand ripples present. The substrate was fairly hard to dig due to the amount of large shell evenly mixed through the substrate to 200mm depth. The substrate was uniform in composition through the 200mm profile. There were no live shellfish seen.

Figure 20 Photo point Y: (left) showing high shell content, (right) showing excavation hole filling in with loose sand as trowel is thrust in full length and high shell content. Depth -3.5m

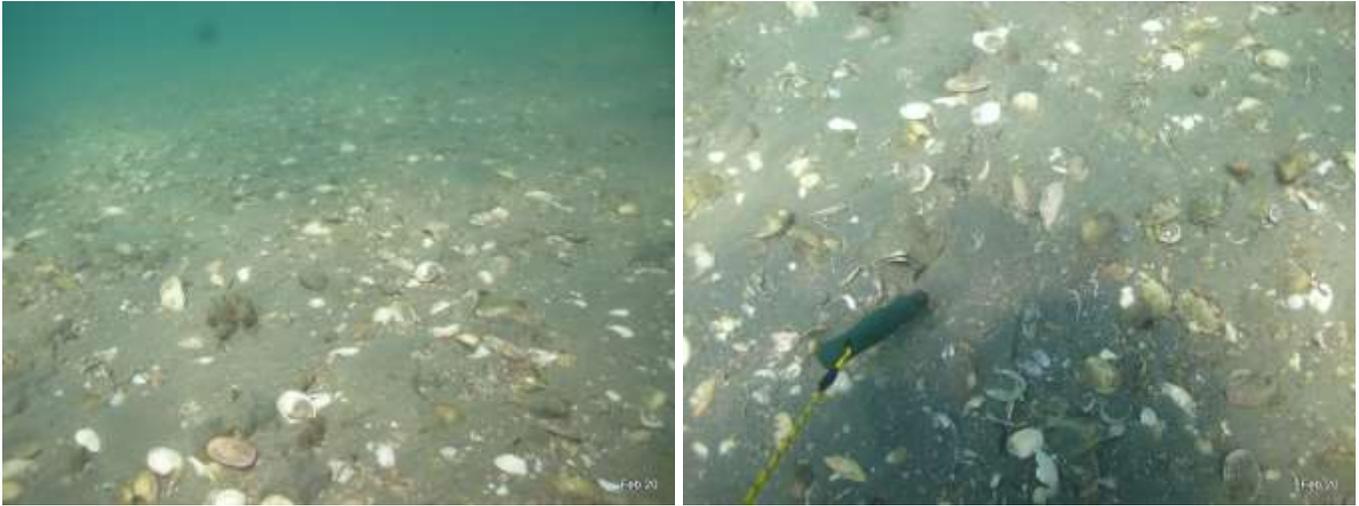
3.2.10 Photo Point Z

Shell content rating = 8 (see Table 1 for description of rating)

Substrate was fine sand with a significant component of shell hash and large dead shell. Large dead shells cover much of the surface. There were no sand ripples present but evidence of some sand movement. The substrate was fairly hard to dig due to the amount of large shell evenly mixed through the substrate to 200mm depth. The substrate was uniform in composition through the 200mm profile. There were no live shellfish seen.

Figure 21 Photo point Z: (left) showing high shell content with some mobile sand, (right) showing excavation hole filling in with loose sand as trowel is thrust in full length and high shell content.. Depth - 3.4m.

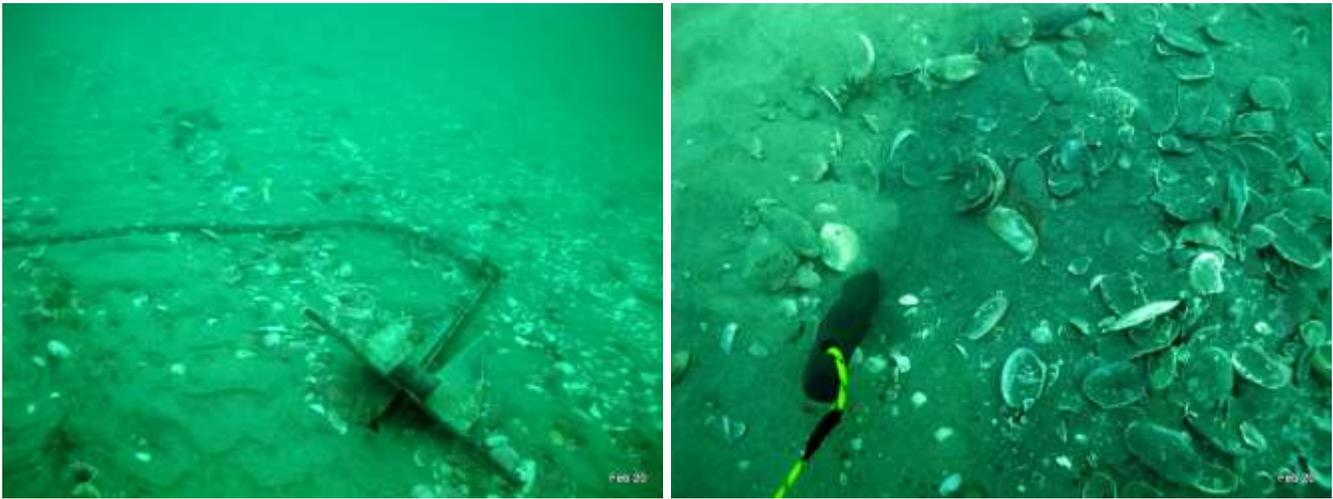
3.3.1 Photo Point L

Shell content rating = 8 (see Table 1 for description of rating)

Substrate was fine sand with a significant component of shell hash and large dead shell. Large dead shells cover much of the surface. There was evidence of some sand moving on the surface. There were no sand ripples present. The substrate was hard to dig due to the amount of large shell evenly mixed through the substrate to 200mm depth. The substrate was uniform in composition through the 200mm profile. There were no live shellfish seen.

Figure 22 Photo point L: (left) showing significant shell content, (right) showing excavation hole filling in with loose sand as trowel is thrust in full length and shell to left excavated from hole. Depth -15.6m.

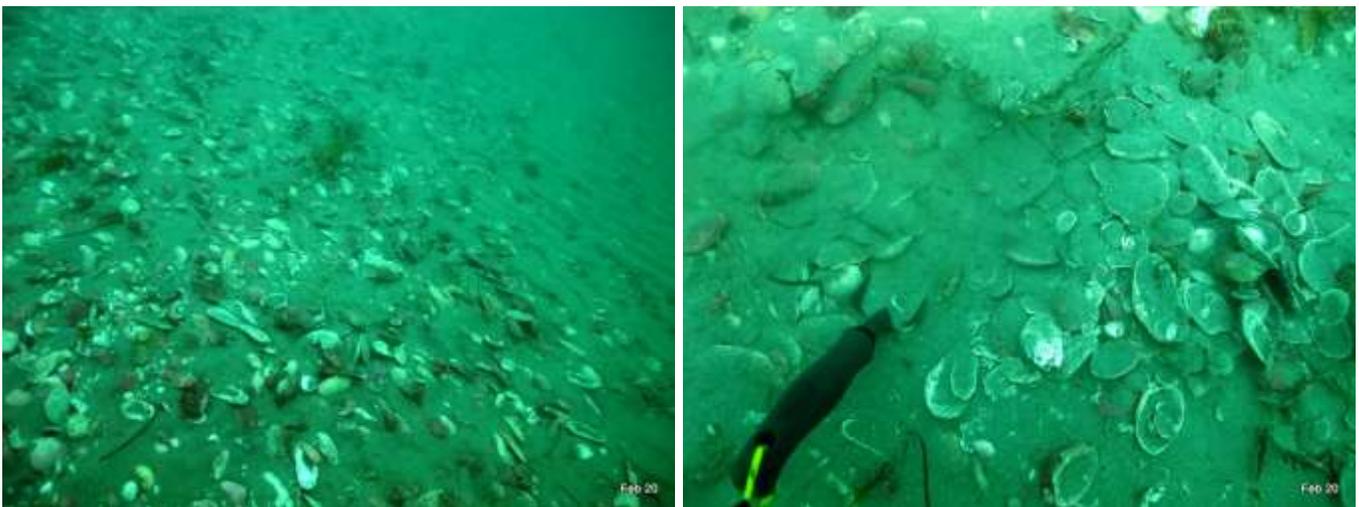
3.3.2 Photo Point M

Shell content rating = 9 (see Table 1 for description of rating)

Substrate was fine sand with a significant component of shell hash and large dead shell. Large dead shells cover much of the surface. There were no sand ripples present. The substrate was hard to dig due to the amount of large shell evenly mixed through the substrate to 200mm depth. The substrate was uniform in composition through the 200mm profile. There were no live shellfish seen.

Figure 23 photo point M showing significant shell content, (right) showing excavation hole filling in with loose sand as trowel is thrust in full length and shell excavated to left from hole. Depth -14.4m.

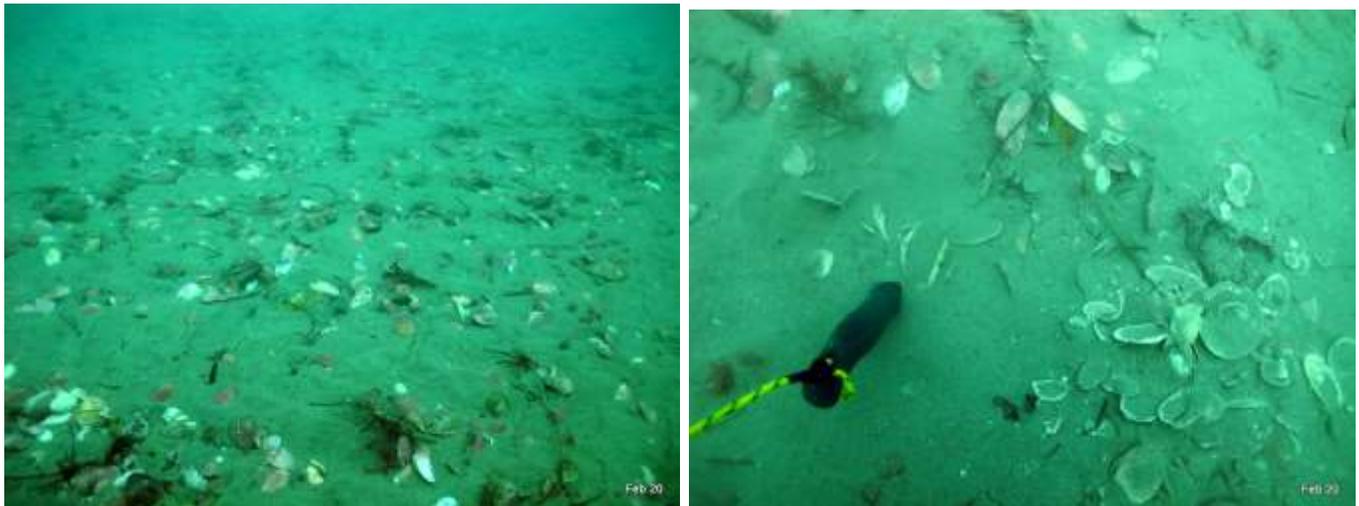
3.3.3 Photo Point N

Shell content rating = 8 (see Table 1 for description of rating)

Substrate was fine sand with a significant component of shell hash and large dead shell. Large dead shells cover much of the surface. There was evidence of some sand moving on the surface. There were no sand ripples present. The substrate was hard to dig due to the amount of large shell evenly mixed through the substrate to 200mm depth. The substrate was uniform in composition through the 200mm profile. There were no live shellfish seen.

Figure 24 Photo point N: (left) showing significant shell content, (right) showing excavation hole filling in with loose sand as trowel is thrust in full length and shell excavated to left from hole. Depth -12.6m.

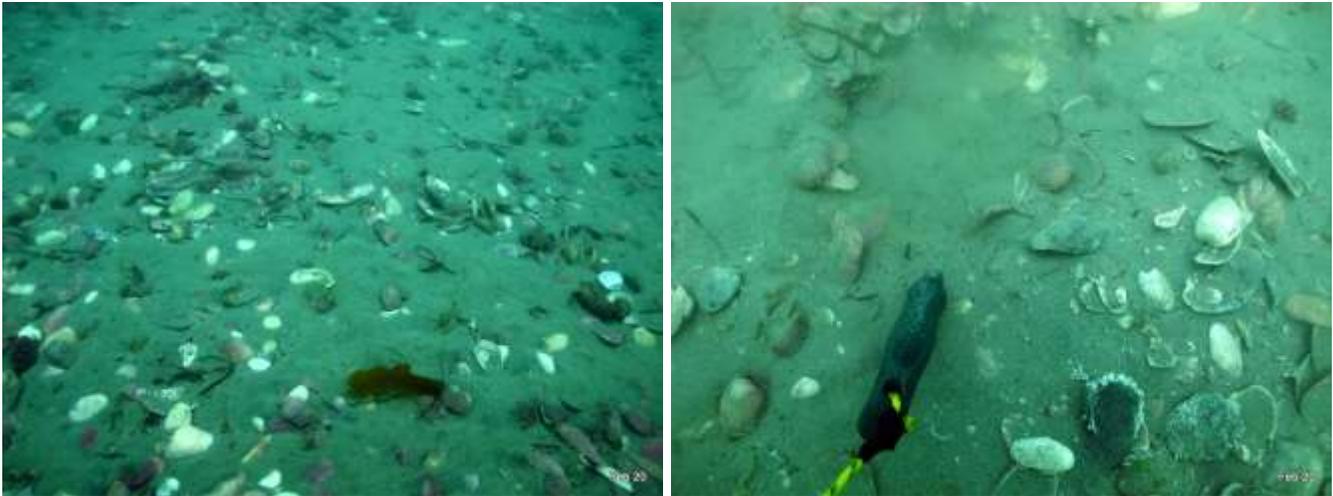
3.3.4 Photo Point O

Shell content rating = 9 (see Table 1 for description of rating)

Substrate was fine sand with a significant component of shell hash and large dead shell. Large dead shells cover much of the surface. There was evidence of some sand moving on the surface. There were no sand ripples present. The substrate was hard to dig due to the amount of large shell evenly mixed through the substrate to 200mm depth. The substrate was uniform in composition through the 200mm profile. There were no live shellfish seen.

Figure 25 Photo point O: (left) showing significant shell content, (right) showing excavation hole filling in with loose sand as trowel is thrust in full length and shell to left excavated from hole. Depth -10.4m.

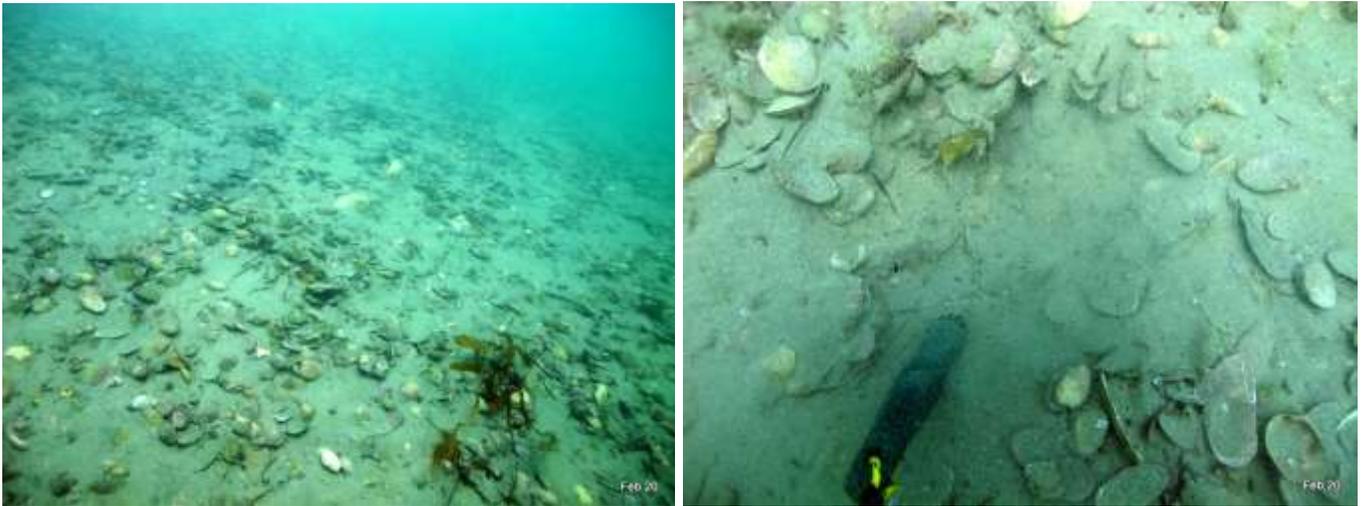
3.3.5 Photo Point P

Shell content rating = 9 (see Table 1 for description of rating)

Substrate was fine sand with a significant component of shell hash and large dead shell. Large dead shells cover much of the surface. There was evidence of some sand moving on the surface. There were no sand ripples present. The substrate was hard to dig due to the amount of large shell evenly mixed through the substrate to 200mm depth. The substrate was uniform in composition through the 200mm profile. There were no live shellfish seen.

Figure 26 Photo point P: (left) showing significant shell content, (right) showing excavation hole filling in with loose sand as trowel is thrust in full length and shell to left excavated from hole. Depth -8.4m.

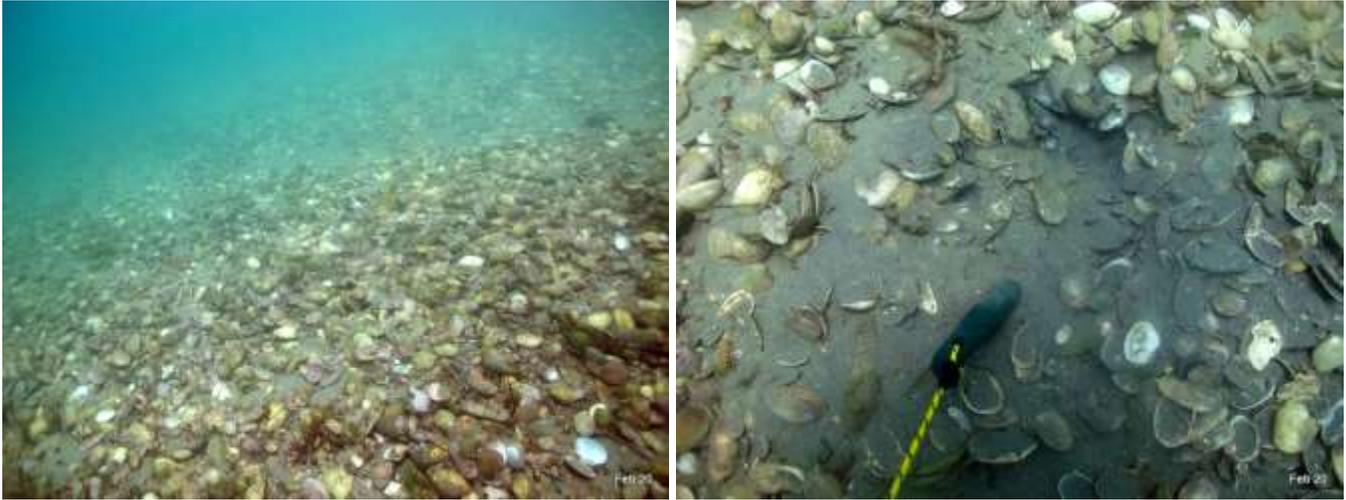
3.3.6 Photo Point Q

Shell content rating = 10 (see Table 1 for description of rating)

Substrate was fine sand with very high proportion of large dead shell. Large dead shells cover the surface. There were no sand ripples present. The substrate was very difficult to dig due to the amount of large shell evenly mixed through the substrate to 200mm depth. The substrate was uniform in composition through the 200mm profile. There were no live shellfish seen.

Figure 27 Photo point Q: (left) showing a high degree of shell content, (right) showing excavation hole filling in with loose sand as trowel is thrust in full length and shell to left excavated from hole. Depth - 5.6m.
