Mair Bank Channel Edge Additional Characterisation:
Crude Freight Shipping Project,
Bream Bay, Whangarei

February 2016

For: Chancery Green on behalf of the Refining NZ

Report by: V.C. Kerr B.Sc.

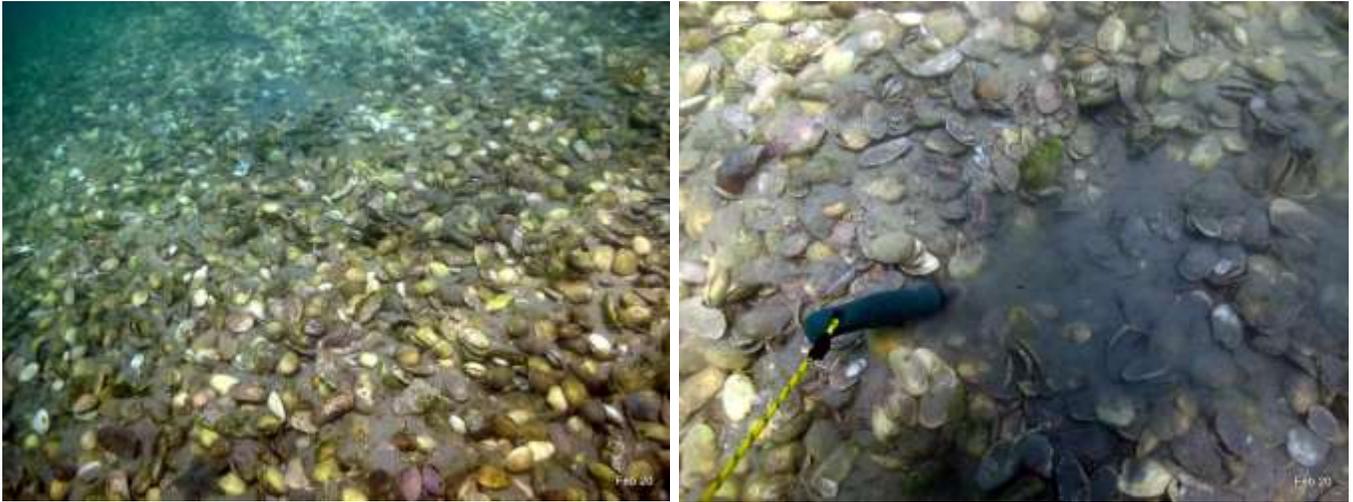
3.3.7 Photo Point R

Shell content rating = 10 (see Table 1 for description of rating)

Substrate was fine sand with very high proportion of large dead shell. Large dead shells cover the surface. There were no sand ripples present. The substrate was very difficult to dig due to the amount of large shell evenly mixed through the substrate to 200mm depth. The substrate was uniform in composition through the 200mm profile. There were no live shellfish seen.

Figure 28 Photo point R: (left) showing a high degree of shell content, (right) showing excavation hole filling in with loose sand as trowel is thrust in full length and shell to left excavated from hole. Depth - 3.1m.

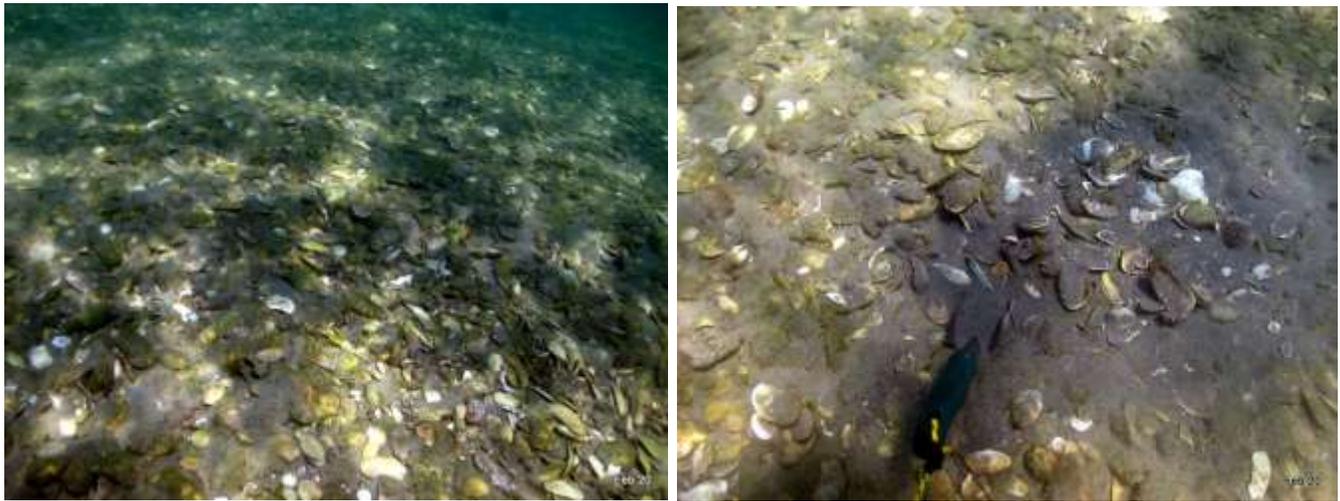
3.3.8 Photo Point S

Shell content rating = 10 (see Table 1 for description of rating)

Substrate was fine sand with a large dead shell content. Large dead shells cover most of the surface. There were no sand ripples present. The substrate was very difficult to dig due to the amount of large shell evenly mixed through the substrate to 200mm depth. The substrate was uniform in composition through the 200mm profile. There were no live shellfish seen. Depth -1.6m.

Figure 29 Photo point S: (left) showing high shell content, (right) showing excavation hole filling in with loose sand as trowel is thrust in full length and shell to left excavated from hole. Depth -1.6m.
